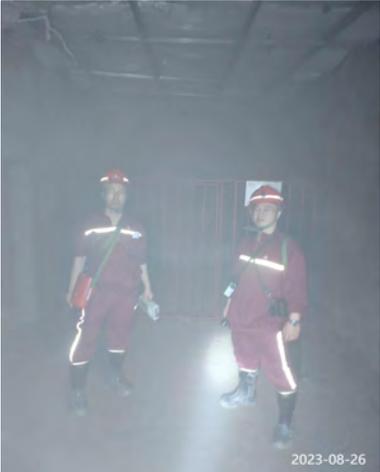
序号	报告编号	发布日期	结论	影像资料
1	GX-B1341/21-9-23218	2023. 9. 1	综合判定：合格。

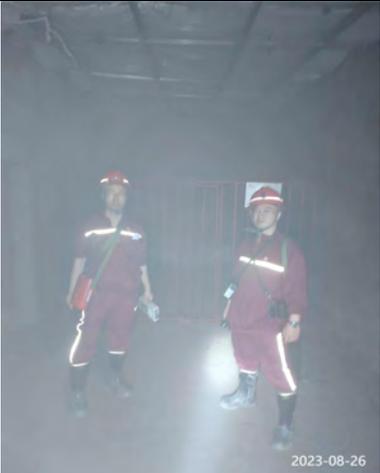
2	GX-B1341/21-9-23219	2023. 9. 1	综合判定：合格。

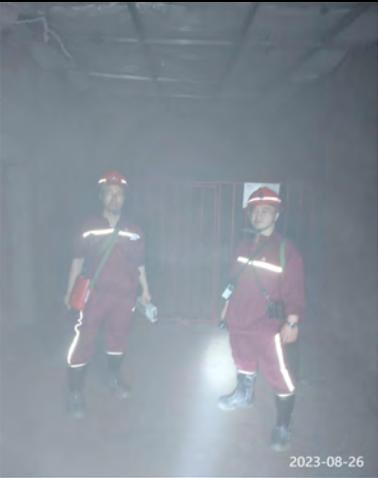
3	GX-B1341/21-9-23220	2023. 9. 1	综合判定：合格。

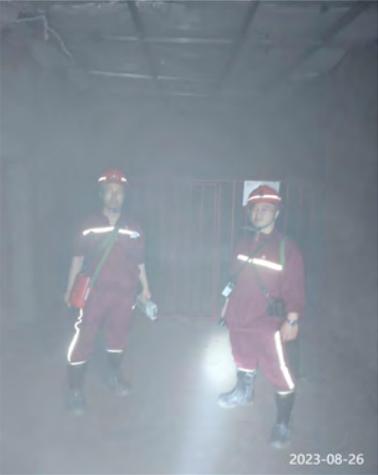
A photograph showing two workers in red safety suits and helmets standing in a dark tunnel. The workers are facing forward, and the scene is dimly lit, with a bright light source visible in the background. The date '2023-08-26' is printed in the bottom right corner of the image.	
4	GX-B1341/21-9-23221	2023. 9. 1	综合判定：合格。

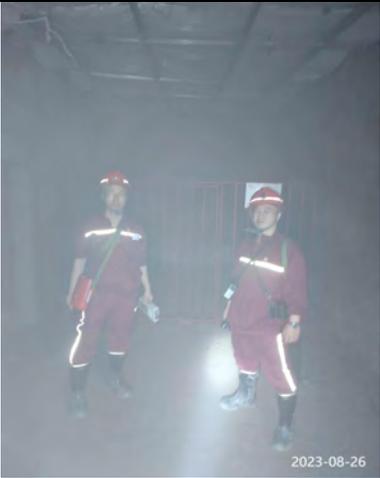
5	GX-B1341/21-9-23222	2023. 9. 1	综合判定：合格。

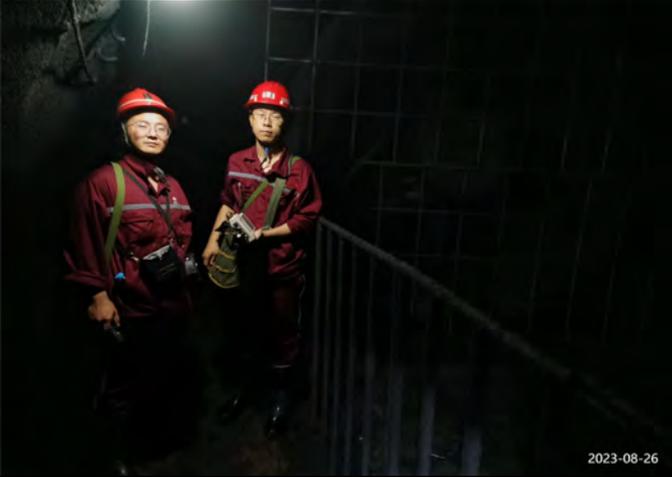
<p>2023-08-26</p>
6	GX-B1341/21-9-23223	2023. 9. 1	综合判定：合格。

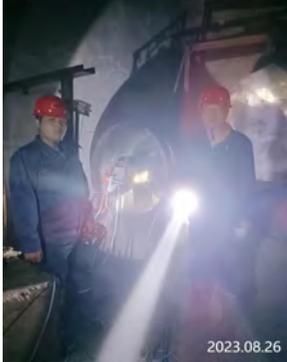
7	GX-B1341/21-9-23224	2023年9月1日	综合判定：合格。

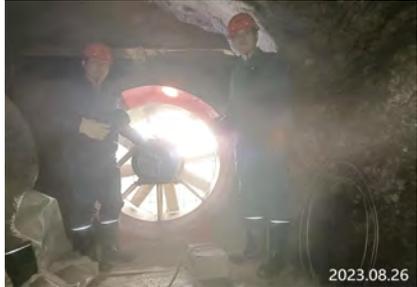
8	GX-B1341/21-9-23225	2023年9月1日	综合判定：合格。

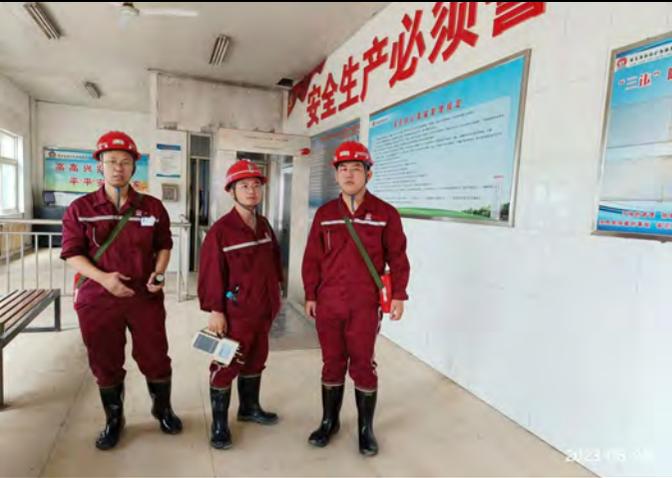
9	GX-B1343/21-9-23042	2023. 9. 1	<ol style="list-style-type: none"> 1. 矿井总风量：8912.4m³/min； 2. 主通风机风量：9076.3m³/min； 3. 矿井有效风量：7247.0m³/min； 4. 矿井有效风量率：79.8%； 5. -155m水平风机4657.8m³/min，-305m水平风机4418.5m³/min； 6. 机站风压：-155m水平风机1030Pa，-305m水平风机1010Pa； 7. 矿井通风阻力：东风井通风系统1013.4Pa；西风井通风系统999.7Pa。

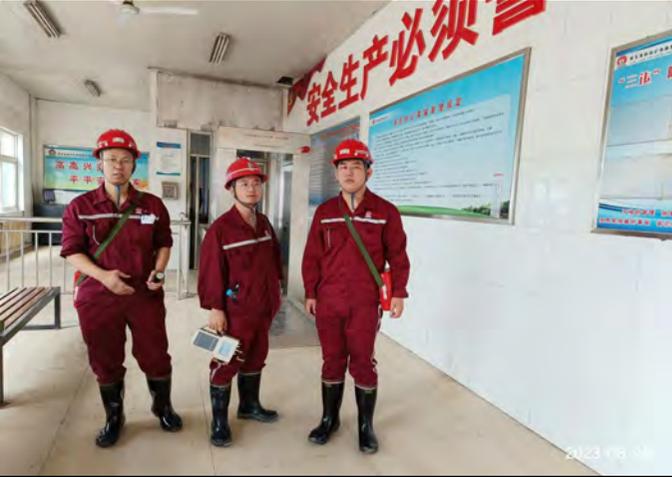
10	GX-B1347/21-9-23028	2023. 9. 1	<ol style="list-style-type: none"> 1. 风量（风速）合格率：100%，大于65%，合格； 2. 风质合格率：100%，大于90%，合格； 3. 作业环境空气质量合格率：100%，大于60%，合格； 4. 矿井有效风量率79.8%，大于60%，合格； 5. 风机全压效率为71.6%，大于70%，合格； 6. 风量供需比1.56，符合$1.32 \leq \beta \leq 1.67$要求，合格； 7. 综合指标91.1%，大于72%，合格。

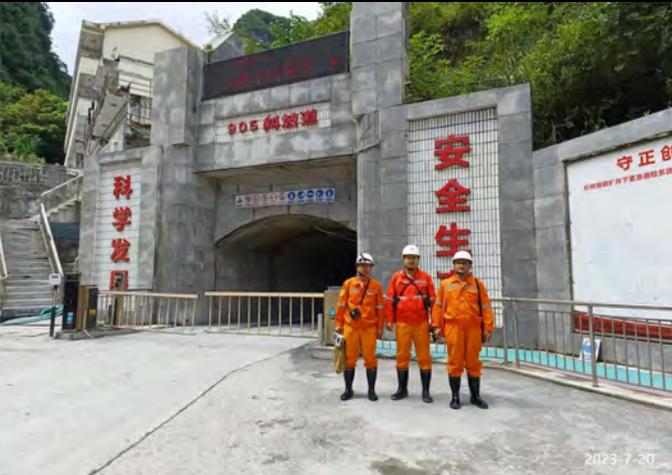
11	GX-B1347/21-9-23035	2023年9月4日	<ol style="list-style-type: none">1. 风量（风速）合格率：100%，大于65%，合格；2. 风质合格率：100%，大于90%，合格；3. 作业环境空气质量合格率：100%，大于60%，合格；4. 矿井有效风量率69.8%，大于60%，合格；5. 风机全压效率为71.0%，大于70%，合格；6. 风量供需比1.63，符合$1.32 \leq \beta \leq 1.67$要求，合格；7. 综合指标89.0%，大于72%，合格。
