| 序号 | 报告编号 | 发布日期 | 结论 | 影像资料 |

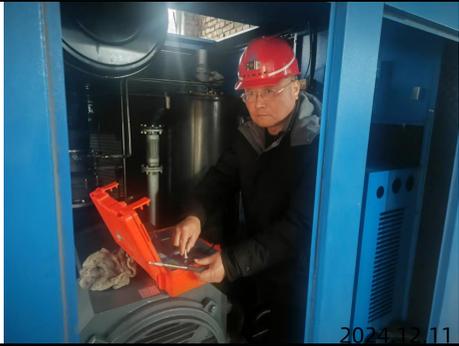
| 64 | GX-B1306/23-4-24011 | 2025. 1. 20 | 综合判定：合格。 | |

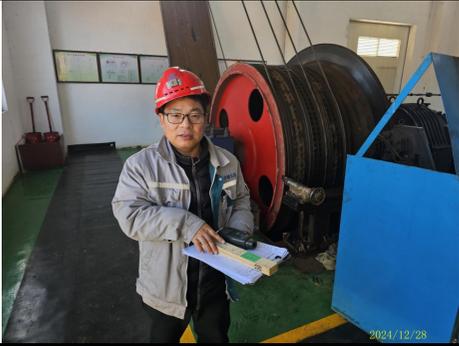
| 65 | GX-B1304/21-4-24005 | 2025. 1. 22 | 综合判定：合格 | |

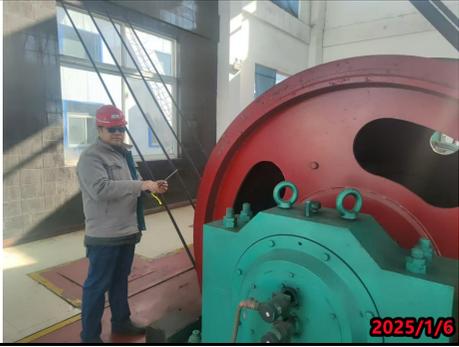
| 66 | GX-B1301/23-4-25001 | 2025/1/20 | 综合判定：合格。 | |

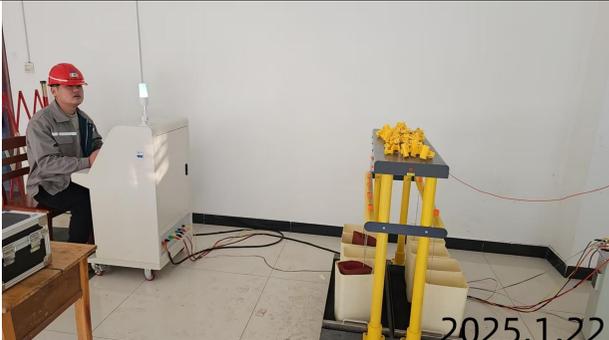
| 68 | GX-B1328/20-4-25003 | 2025. 1. 22 | 本次共检绝缘手套6只，6只所检项目合格。 | |

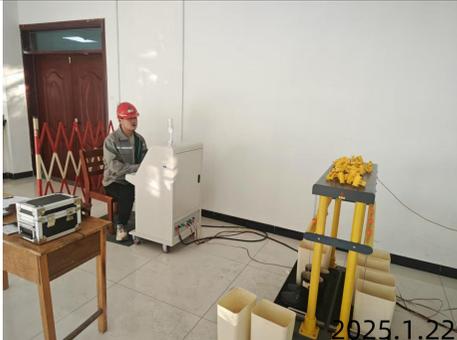
| 69 | GX-B1328/20-4-25004 | 2025. 1. 22 | 本次共检绝缘鞋8只，8只所检项目合格。 | |

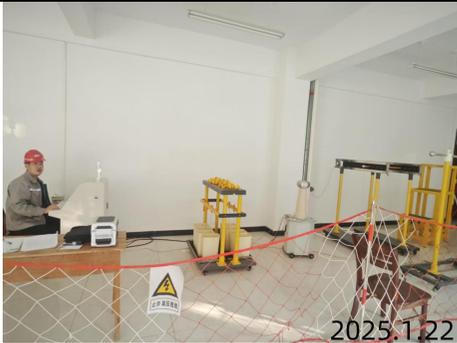
| 70 | GX-B1328/20-4-25005 | 2025. 1. 22 | 本次共检绝缘杆2只，2只所检项目合格。 | |

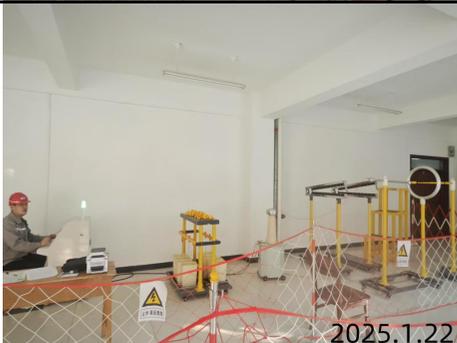
| 71 | GX-B1328/20-4-25006 | 2025. 1. 22 | 本次共检验电器3支，3支所检项目合格。 | |

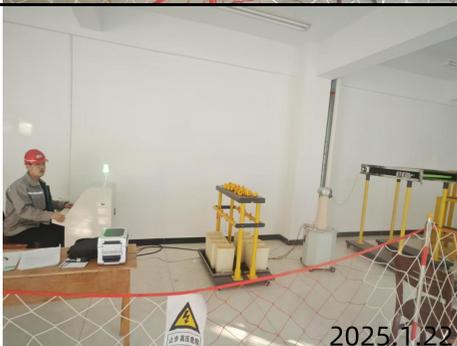
| 72 | GX-B1328/20-4-25007 | 2025. 1. 22 | 本次共检便携式短路接地线3套，3套所检项目合格。 | |

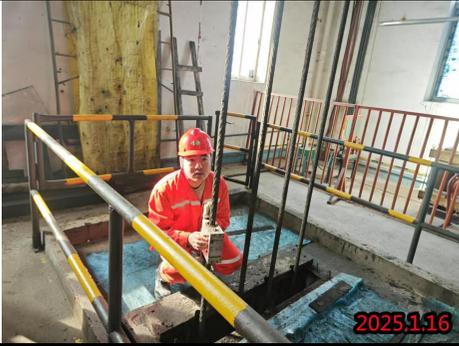
| 77 | GX-B1598/24-4-25001 | 2025. 1. 23 | 实测钢丝绳有效截面积 损失百分比最大为 1.55%，小于5%为正常。 | |

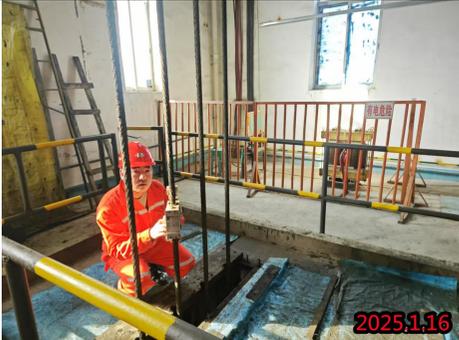
| 78 | GX-B1598/24-4-25002 | 2025. 1. 23 | 实测钢丝绳有效截面积 损失百分比最大为 1.80%，小于5%为正常。 | |

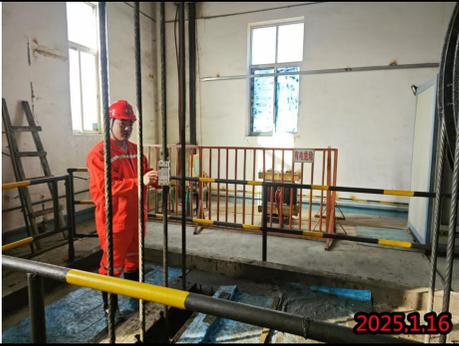
| 79 | GX-B1598/24-4-25003 | 2025. 1. 23 | <p>实测钢丝绳有效截面积 损失百分比最大为 1.82%，小于5%为正常。</p> | |

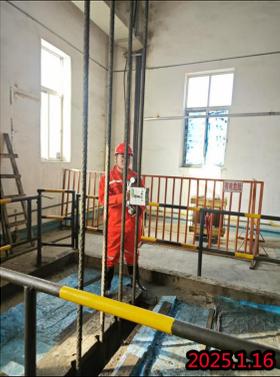
| 80 | GX-B1598/24-4-25004 | 2025. 1. 23 | <p>实测钢丝绳有效截面积 损失百分比最大为 0.79%，小于5%为正常。</p> | |

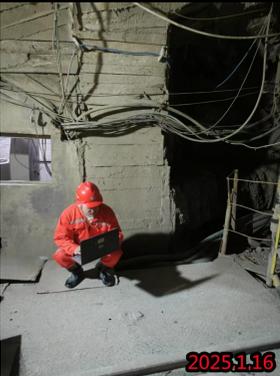
| 81 | GX-B1598/24-4-25005 | 2025. 1. 23 | <p>实测钢丝绳有效截面积 损失百分比最大为 2.13%，小于5%为正常。</p> | |

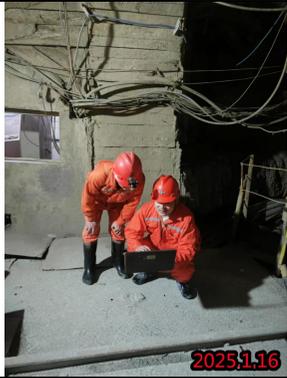
| 82 | GX-B1598/24-4-25006 | 2025. 1. 23 | <p>实测钢丝绳有效截面积 损失百分比最大为 1.52%，小于5%为正常。</p> | <p>2025.1.16</p> |

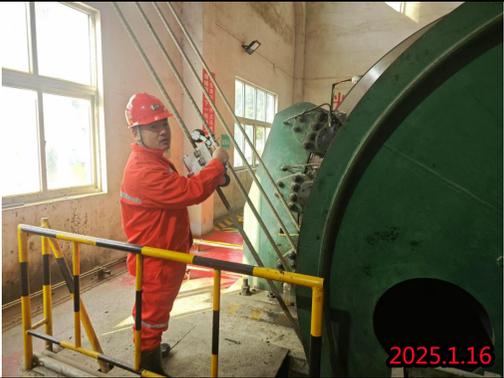
| 83 | GX-B1598/24-4-25007 | 2025. 1. 23 | <p>实测钢丝绳有效截面积 损失百分比最大为 2.02%，小于5%为正常。</p> | <p>2025.1.16</p> |

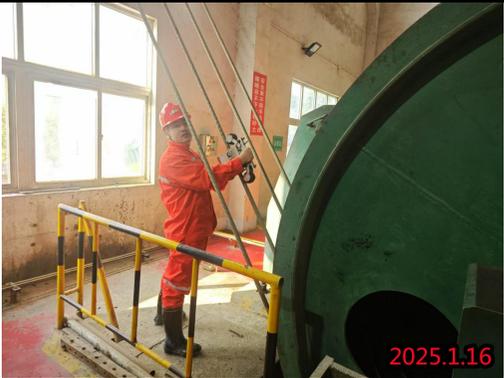
| 84 | GX-B1598/24-4-25008 | 2025. 1. 23 | <p>实测钢丝绳有效截面积 损失百分比最大为 2.32%，小于5%为正常。</p> | <p>2025.1.16</p> |

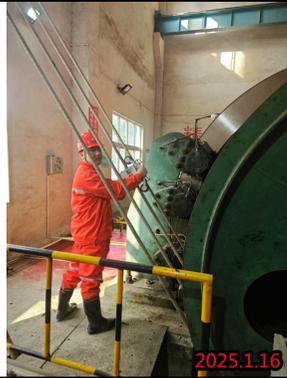
| 85 | GX-B1598/24-4-25009 | 2025. 1. 23 | 实测钢丝绳有效截面积 损失百分比最大为 1.54%，小于5%为正常。 | |

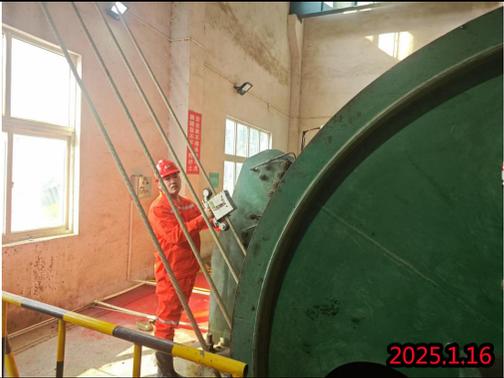
| 86 | GX-B1598/24-4-25010 | 2025. 1. 23 | 实测钢丝绳有效截面积 损失百分比最大为 0.73%，小于5%为正常。 | |

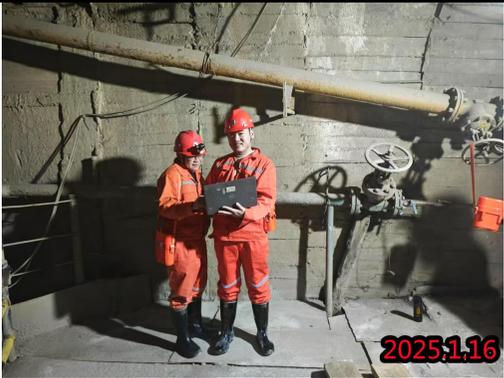
| 87 | GX-B1598/24-4-25011 | 2025. 1. 23 | 实测钢丝绳有效截面积 损失百分比最大为 2.58%，小于5%为正常。 | |

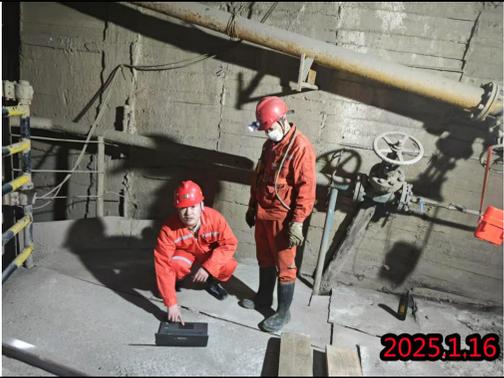
| 88 | GX-B1598/24-4-25012 | 2025. 1. 23 | 实测钢丝绳有效截面积 损失百分比最大为 2.39%，小于5%为正常。 | |

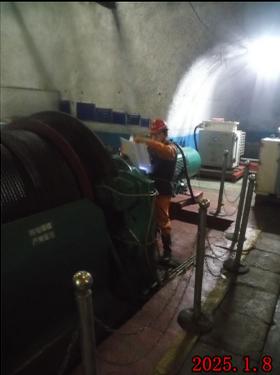
| 89 | GX-B1302/23-4-25001 | 2025. 1. 24 | 综合判定：合格。 | |
